This trackless bond coat was shot for ALDOT on SR-102 in Walker County. Full proper coverage of bond coat and quick return to paving are features for this treatment.

BACKSTORY:

The project is located on SR-102 in Walker County. This is located in the ALDOT West Central Region. The weather started off in the mid 50s and rose to the low 70s.

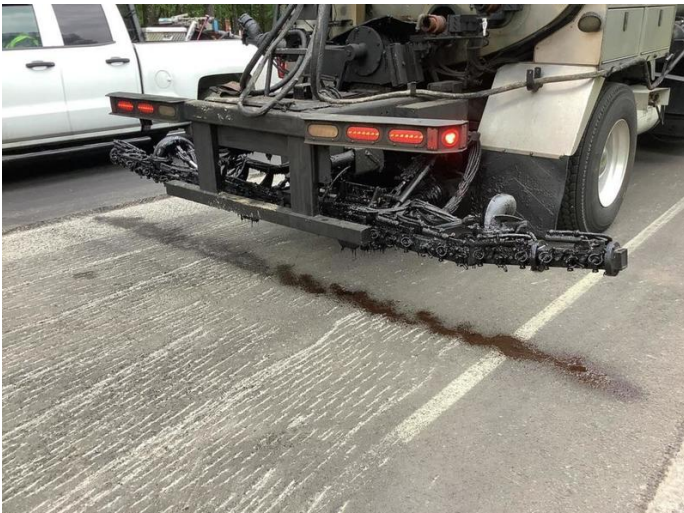
Prior to shooting trackless tack and checking each nozzle.

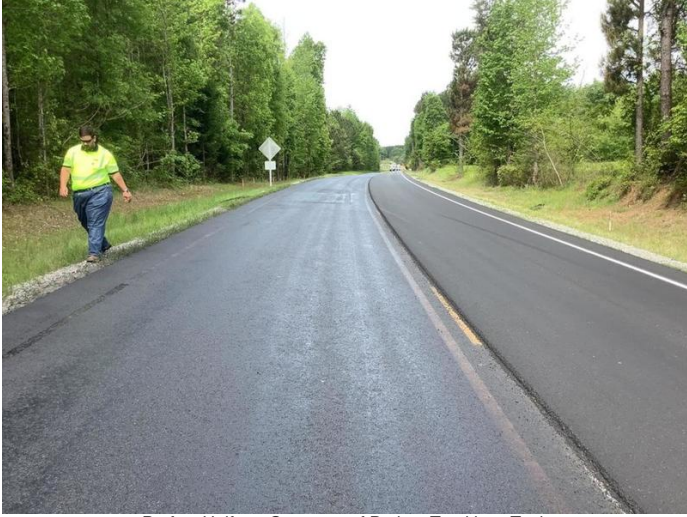
Perfect Uniform Coverage of Broken Trackless Tack
