Victoria, Australia utilizes pavement preservation techniques for higher quality roads, supporting heavy traffic, with a lower project cost.

**BACKSTORY:**

A section of arterial road in Benalla, Victoria experiences a heavy flow of both commercial and residential traffic, with more than 9,000 vehicles per day. The wear and tear from the high volume of traffic, and the turning and torque of heavy vehicles required a massive maintenance program to repair and extend their lifespan.

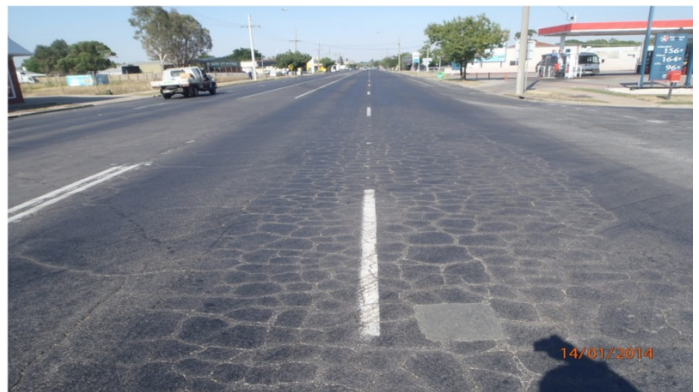
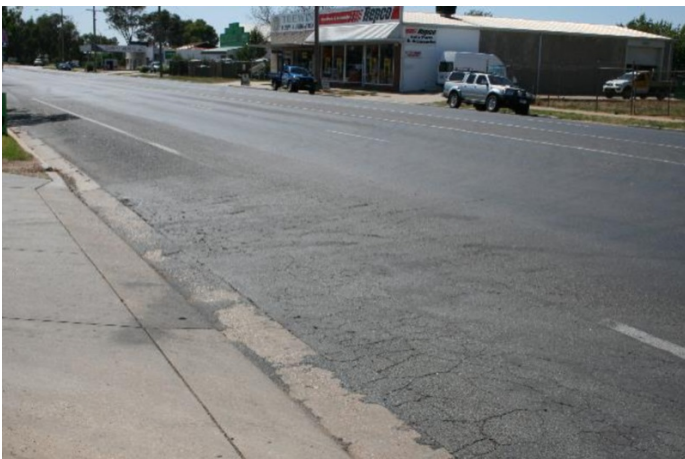
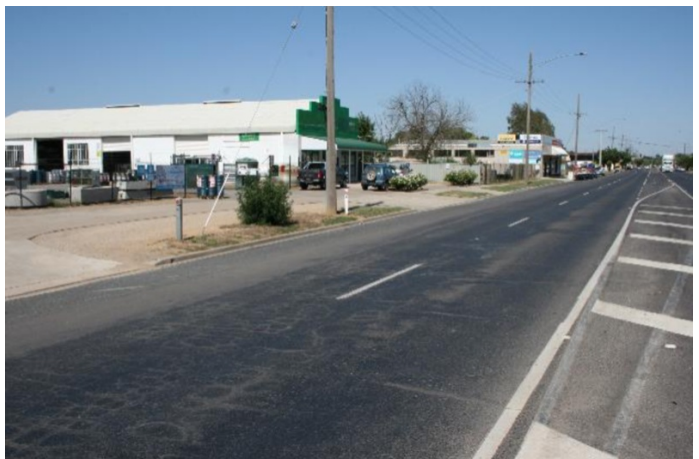
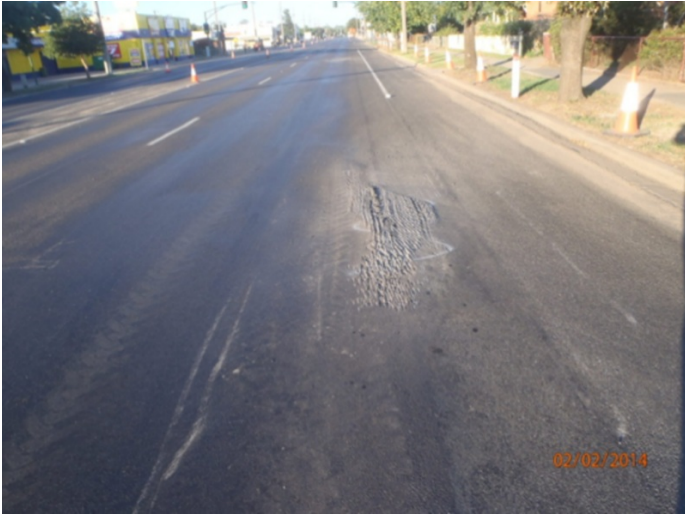
Pre-existing Condition - January 2014

North Eastern Maintenance Alliance teamed with Downer Group to provide a preservation treatment using a Polymer Modified Binder (PMB) Spray Seal, overlaid with a Microsurfacing SFT (Suspended Fibre Technology) Cape Seal, cutting expenses, emissions and time. This type of treatment provided a cost effective, highly flexible, waterproof film coupled with a hard wearing surface to accommodate high volumes of vehicles, turning traffic and sound reduction. Six years after completion, the road is maintaining a high condition with minimal wear.

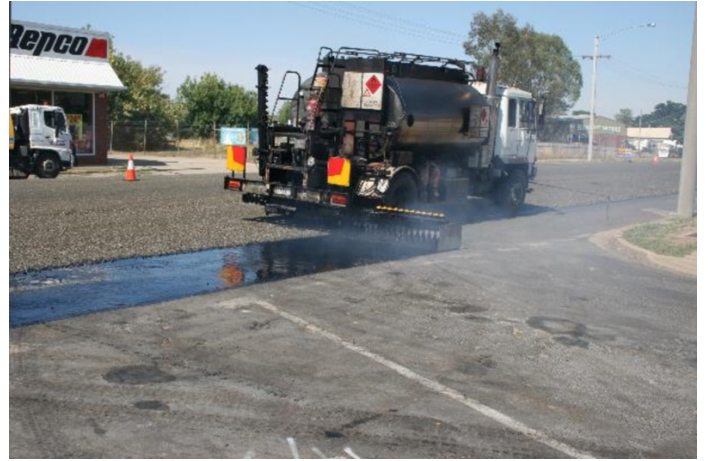
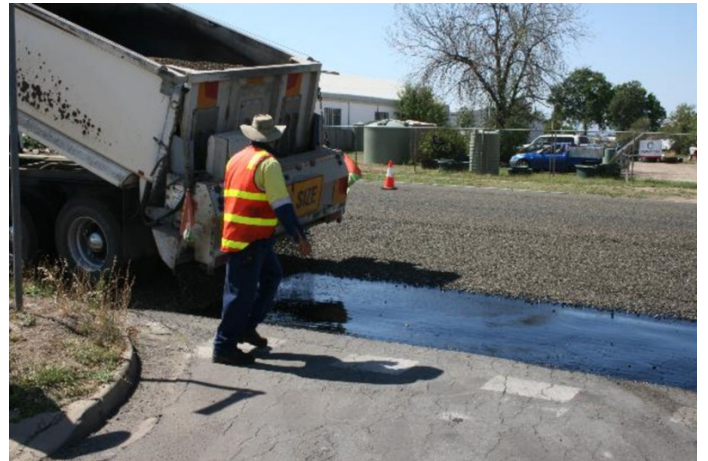
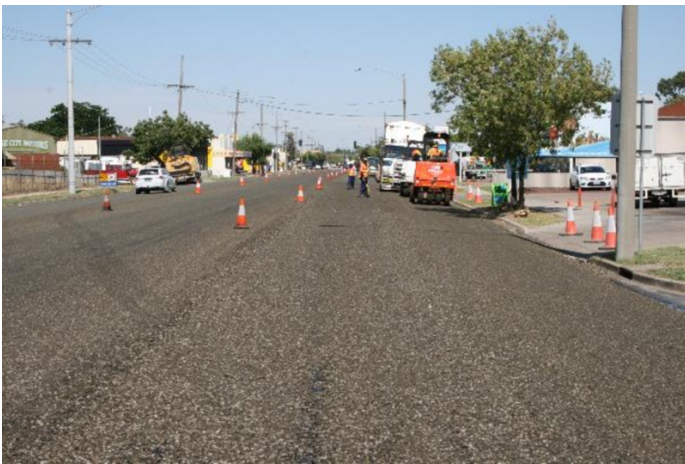
Installing the seal February 2014

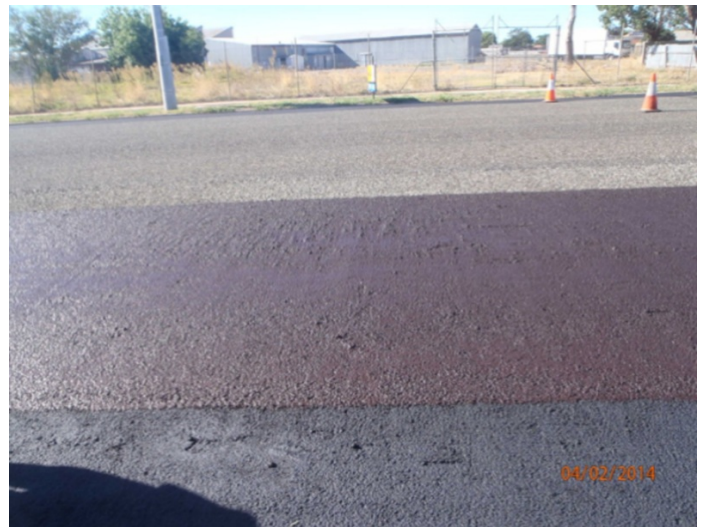
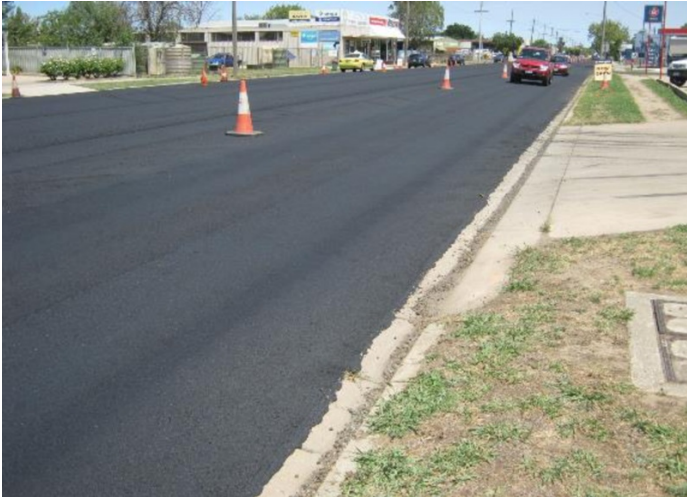
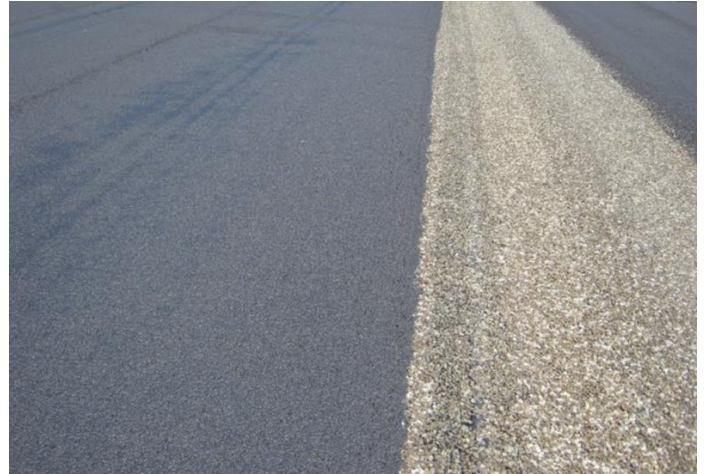
Installing the Micro Surfacing

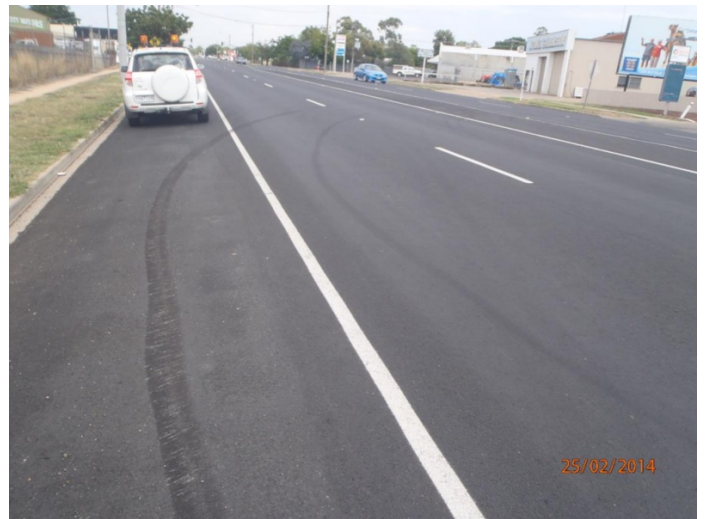
Completed Surface 2014
