Using Optimized Solutions for Extreme Soil Conditions

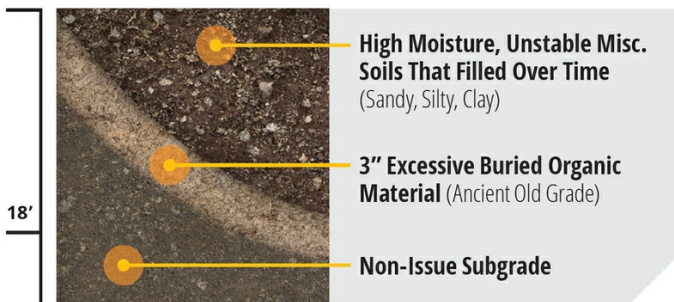
THE PROBLEM

Engineers were faced with solving foundation issues caused by improperly placed fill soil with high moisture content that had been placed atop 3' of buried organic material, reaching depths of up to 18'. This combination made standard foundation construction impossible, prompting engineers to explore alternate solutions like every costly caissons or worse yet, total removal and replacement.

CURRENT GRADE
