Contractor successfully repaired Lake Louise Marie Road in the Town of Thompson located in Sullivan County New York. Fiber reinforced interlayer with a Paver Placed Surface Treatment overlay.

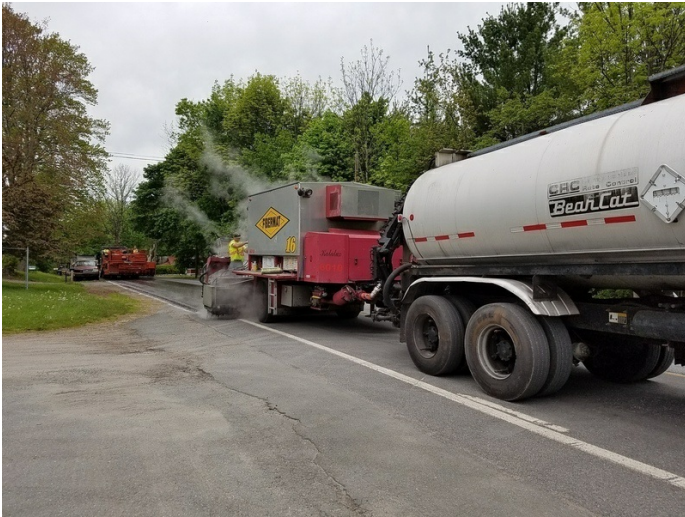
The Gorman Group laying interlayer fiber reinforced system

With the town working on a low dollar budget and in a high traffic area, the fiber reinforced interlayer was selected to reinforce the pavement in preparation for surface overlay. The Paver Placed Surface Treatment was selected (PPST Type B) to provided a high friction surface wearing course. With busy intersections and high volume from local buisnesses this project has out performed prior traditional hot mix overlay. This two part pavement preservation system has in turn resulted in revitalizing a deteriorating road back to life for years to come.

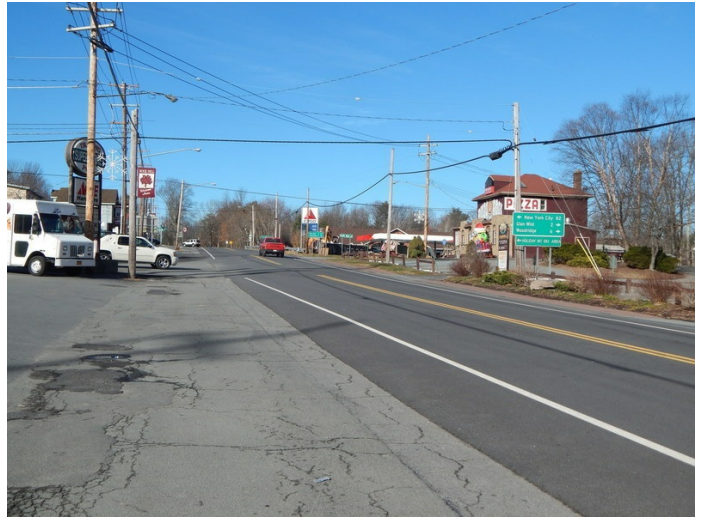
Lake Louise Marie Road finished with PPST Type B

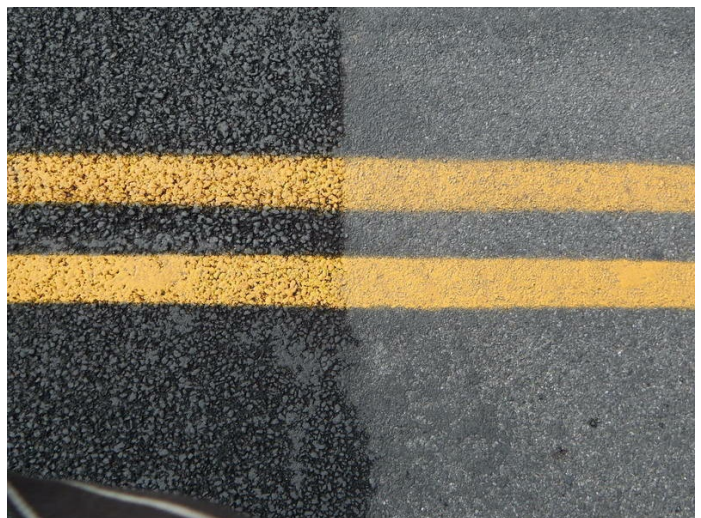
Finished Surface comparison - fiber reinforced interlayer with chip finish on right / PPST Overlay Finish on left
